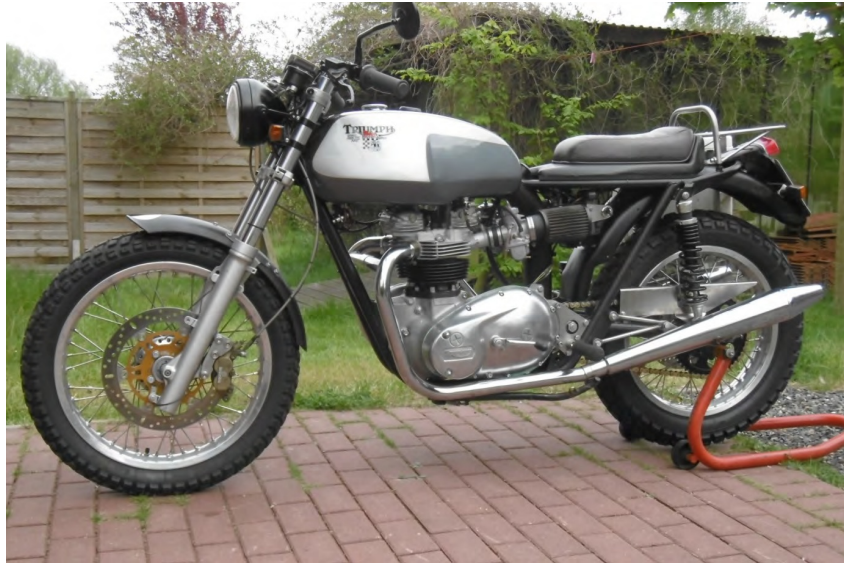
***Above: The "Winkelmann" Triumph***

After the test ride he rang me and wanted another pair for his customer to keep this pair on his personal bike. He reported exhaust noise was significantly reduced and, even more to his taste, the bike vibrated less and if anything felt livelier and more powerful.

His comment: "The new Roadster Silencers at last with baffling and excellent finish. The disadvantage is higher weight of 400 grams per silencer which means 800 grams for a twin and, due to the higher weight, a possible decrease in acceleration."

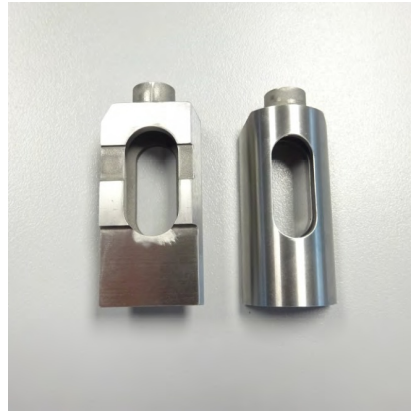
The alloy is Cobalt / Chrome, has good wear characteristic and a hardness of 52-54HRc. This hardness range was selected to try and suit all cams and to ensure that one part will wear quicker than the other. This is normal as you can't have the luxury of both parts never wearing out. Metallurgy has not yet perfected that.

**New tappets - One casting.**

So what went wrong? Some have questioned the expansion of the new alloy. The expansion of this new alloy is 0.0001" more than the cast iron tappets at 108 C, so not enough to explain the seizure. This now suggests that clearance could have been an issue. From the drawings it can be found that tappets are of 1.185/1.186" diameter, the tappet tunnel is 1.1865/1.1875. From this you can see that the tolerance varies from 0.0005 - 0.0025".

This suggests that the max clearance is 0.0025" but what is the minimum clearance? 0.0005" is way too low for a the length of the tappets running in a bore. From the figures the max diameter tappets would measure 1.186" in a max diameter bore of 1.1875" suggesting the minimum clearance is more realistic 0.0015" With the new German precision made tappets I have managed to get them to slide into a new tappet tunnel and not be able to get a feeler gauge down the side of them. Just because the slide into the tappet tunnel does not mean they fit correctly, they need clearance and from the drawings the figures obtained then there must have been fitting instructions in the factory during the 60' & 70's - what was it they used? I contacted two ex-employees from that period and neither could remember anything, but there must have been something - the numbers above indicate that.

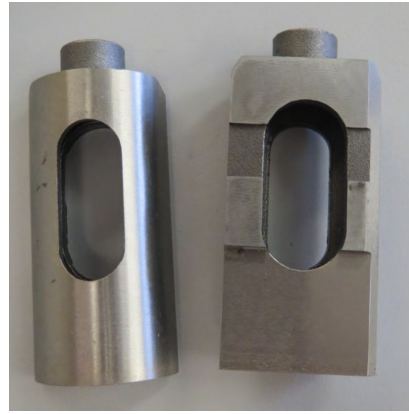
**Old type - Composite Construction.**
